# **PWI-related works performed in IPPLM and WUT**

**Presented by Monika KUBKOWSKA**

**Association Euratom-IPPLM Council Meeting  
March 15, 2013**

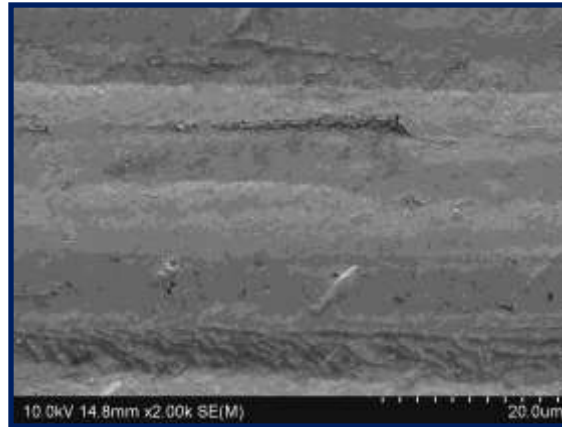
**SEM images of the tile surface**

- ❖ **Results:**
  - The surface of the large sample is covered by a deposit of stratified character.
  - Two large cracks were found at the surface. The long transverse crack (to the longer tile side) crosses almost entire sample thickness. The longitudinal is 15 mm long. Additionally, the transverse “scratch-like” cracks and cracks with the deposit built up were found. At the surface thin, “veins-like” cracks were also present.

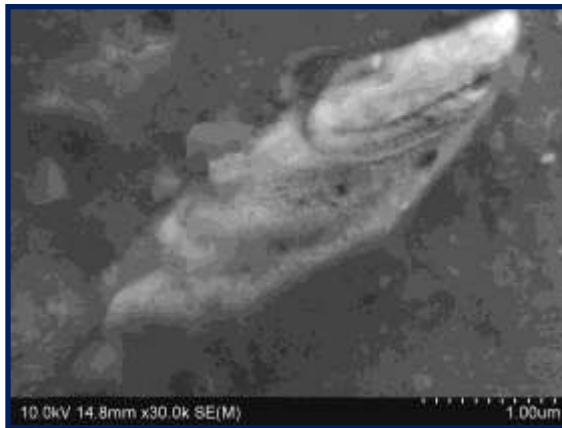
**SEM images of the artefacts present at the large sample surface**

- Artefacts in the form of small, elongated and aligned discs, up to 10  $\mu\text{m}$  long were found. They are spread over entire surface of the large sample. These elements are strongly porous, sometimes with multilayered structure and a characteristic cup. They are a result of the presence of droplets or dust particles at the surface and the formation of a shadowed area behind them.

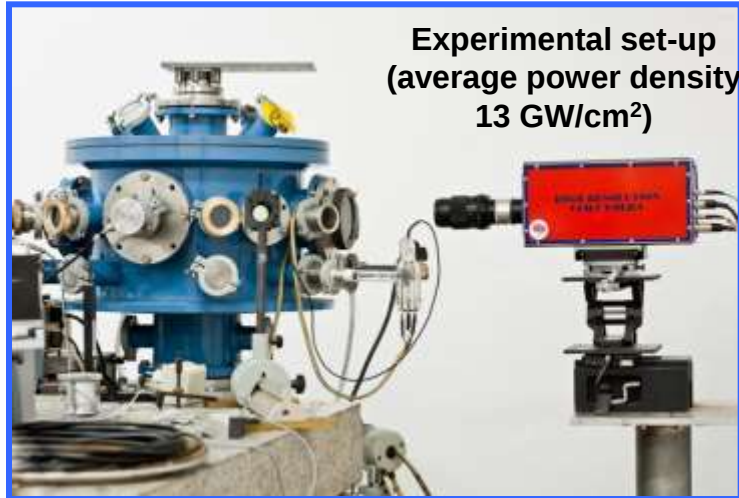
- ❖ TEXTOR sample deposited with deuterium-containing layers was irradiated by nanosecond Nd:YAG laser pulses (3.5 ns, 0.5J@1063nm). Dust which was released in this process was observed by the means of CCD camera and was collected in aerogel collectors provided by VR, Sweden.

A CCD camera image of the expanding dust in absence of aerogel in the chamber taken 24 $\mu$ s after laser pulse, exposure time was 100  $\mu$ s. Estimated velocity 100 m/s
